Understanding Your Historic Building

Historic Structure Reports & Steeple Assessments Overview

The Academy Hall

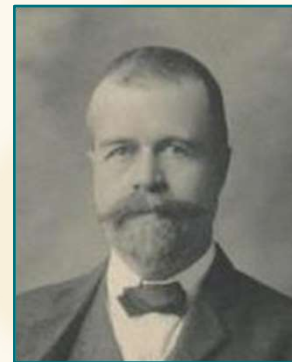
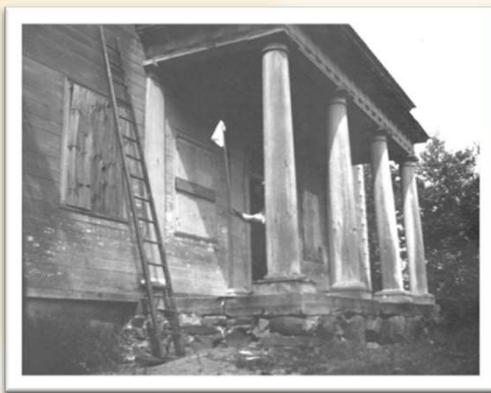
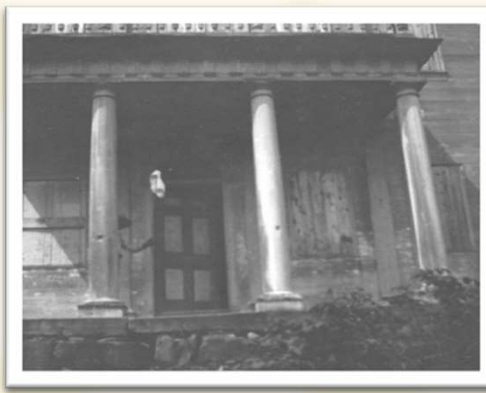
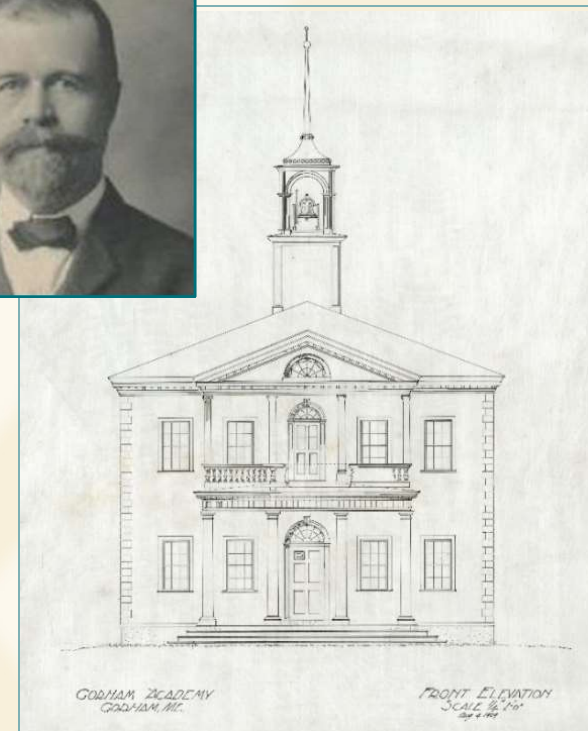
John Calvin Stevens Renovation - 1909

- Stevens is one of Maine's most notable architects
- His work helped restore the Academy Building, which by 1909 had fallen into disrepair (below)

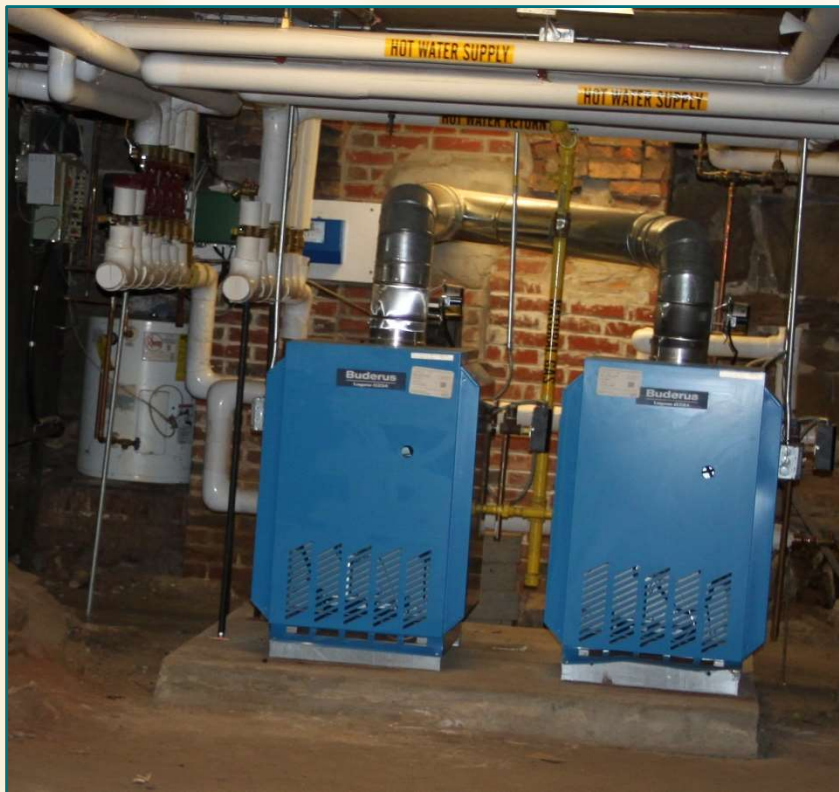
Existing Conditions: HVAC

- The main HVAC system includes
 - 2 energy recovery ventilators
 - 2 natural gas boilers
 - 1 hot water expansion tank
- Current ventilation insufficient
- Boilers are approximately 10 years old and in good condition.
- Hot water heaters and insulated piping were installed in 2013 and remain functional

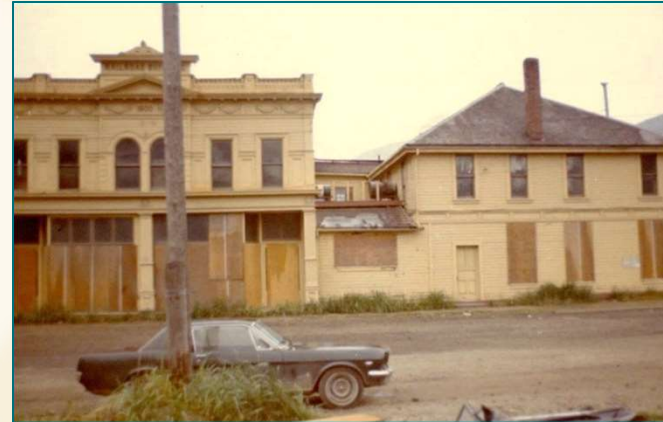
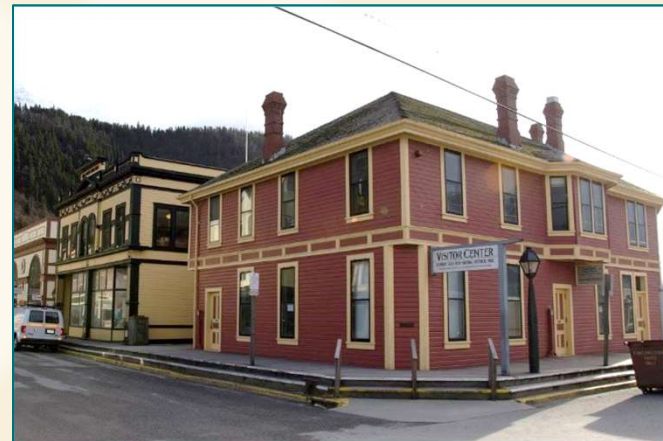
Historic Preservation of storefronts at Yukon Gold Rush National Historic Park (photos courtesy of NPS)

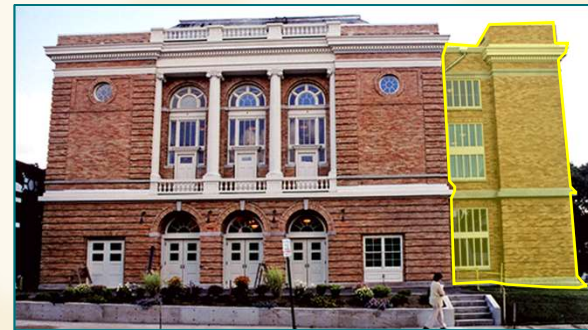
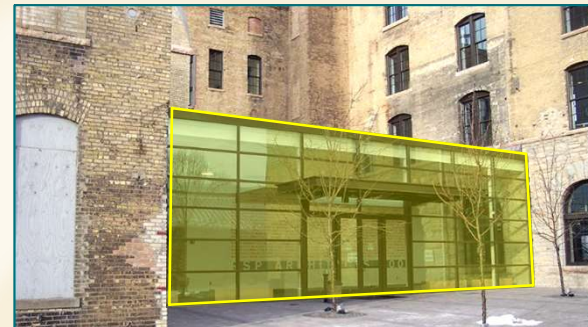
Rehabilitation projects with sensible additions
(photos courtesy of NPS)

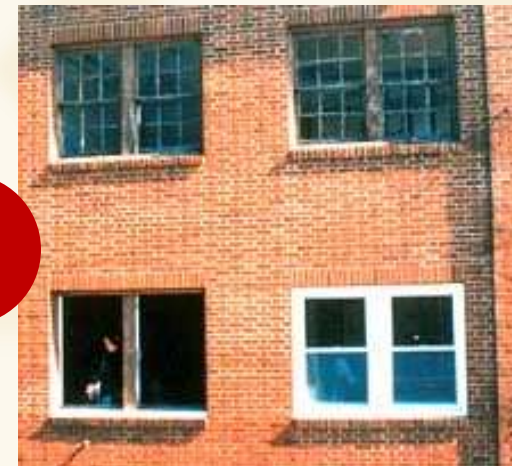
Replaced windows that damage historic character

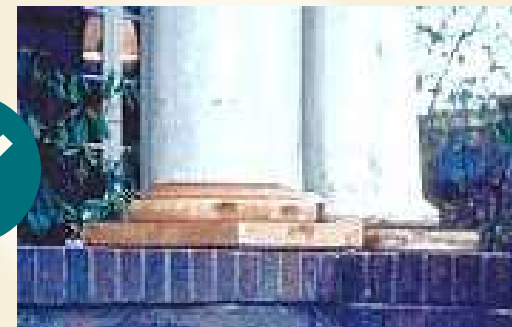
Replaced column base that matches looks and material
(photos courtesy of NPS)

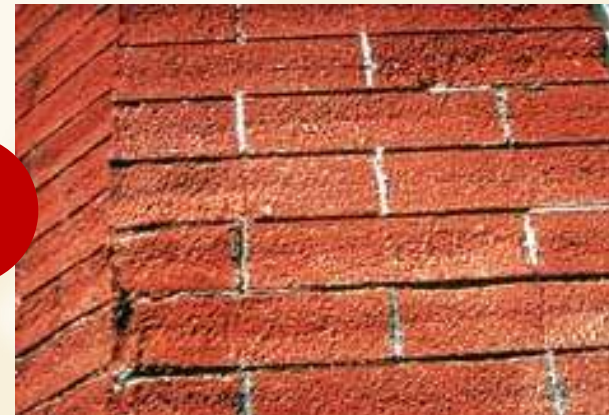
Bricks damaged from sandblasting (photos courtesy of NPS)

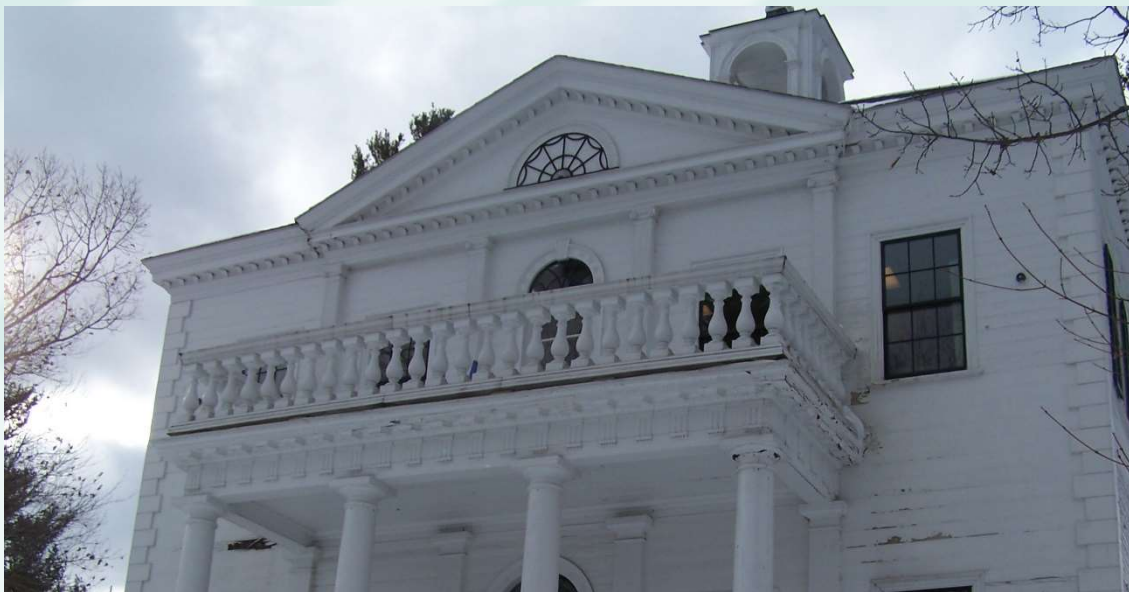
Project 1a

Gable face and details, flashing, trim, some roofing, porch rails and details, soffit, building siding and painting above second floor

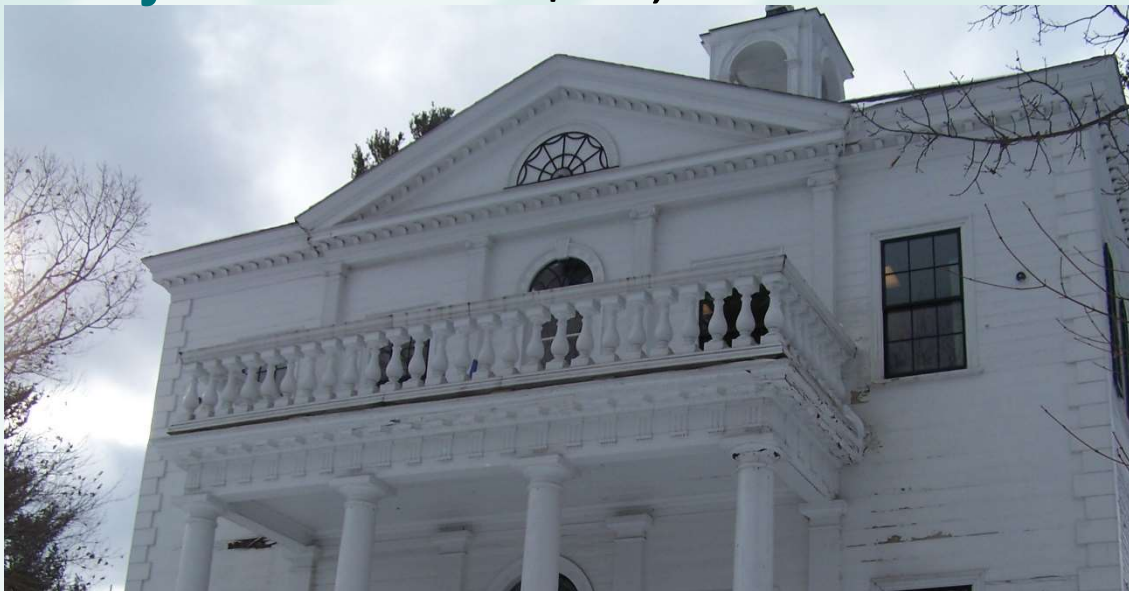
Project 1a Cost: \$93,300

Gable face and details, flashing, trim, some roofing, porch rails and details, soffit, building siding and painting above second floor

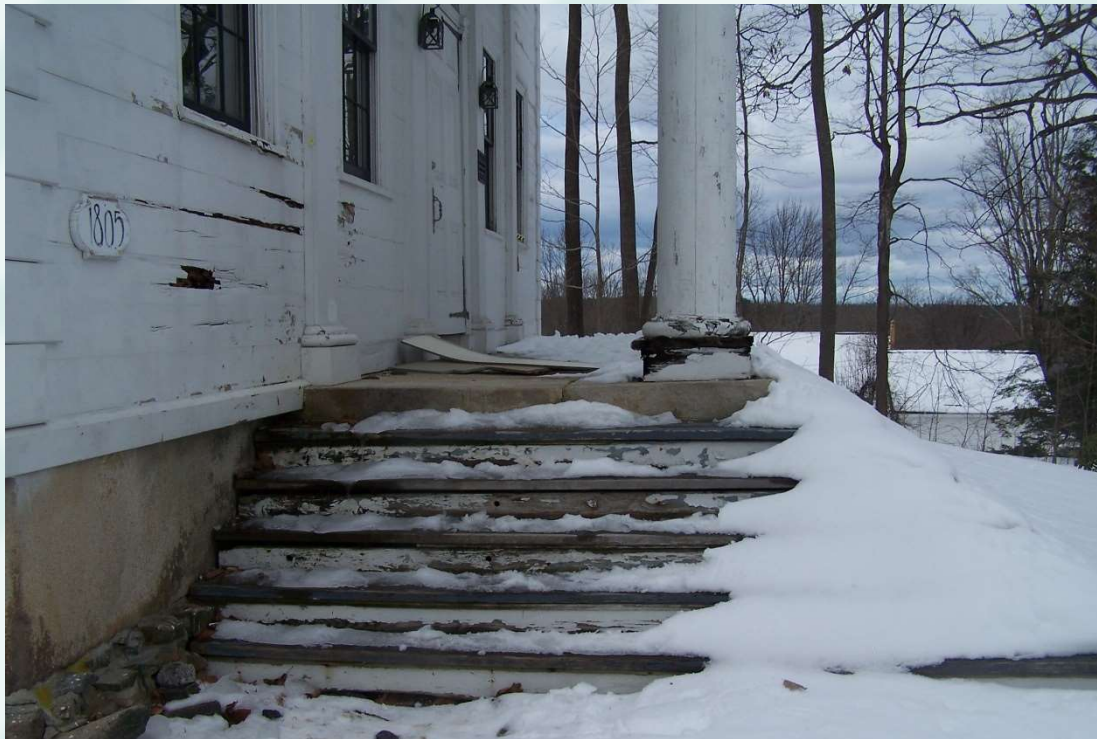
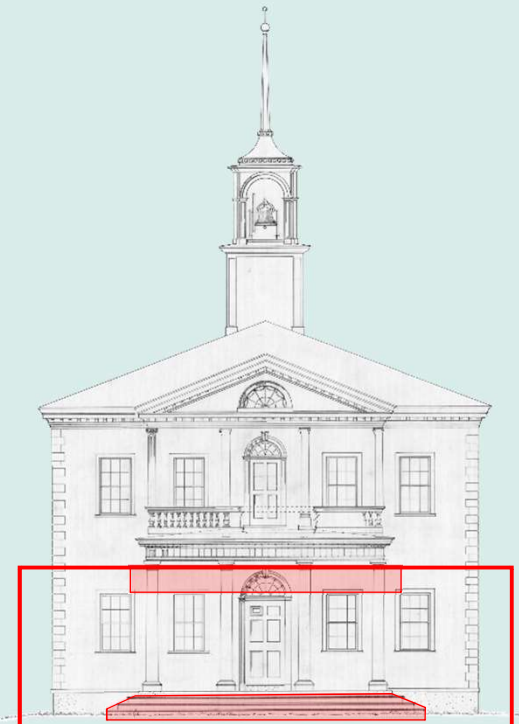
Project 1b

Porch columns, base, capitols, and details;
remove and reset granite; repair foundation; new
wood steps; and siding repair and painting below
second floor

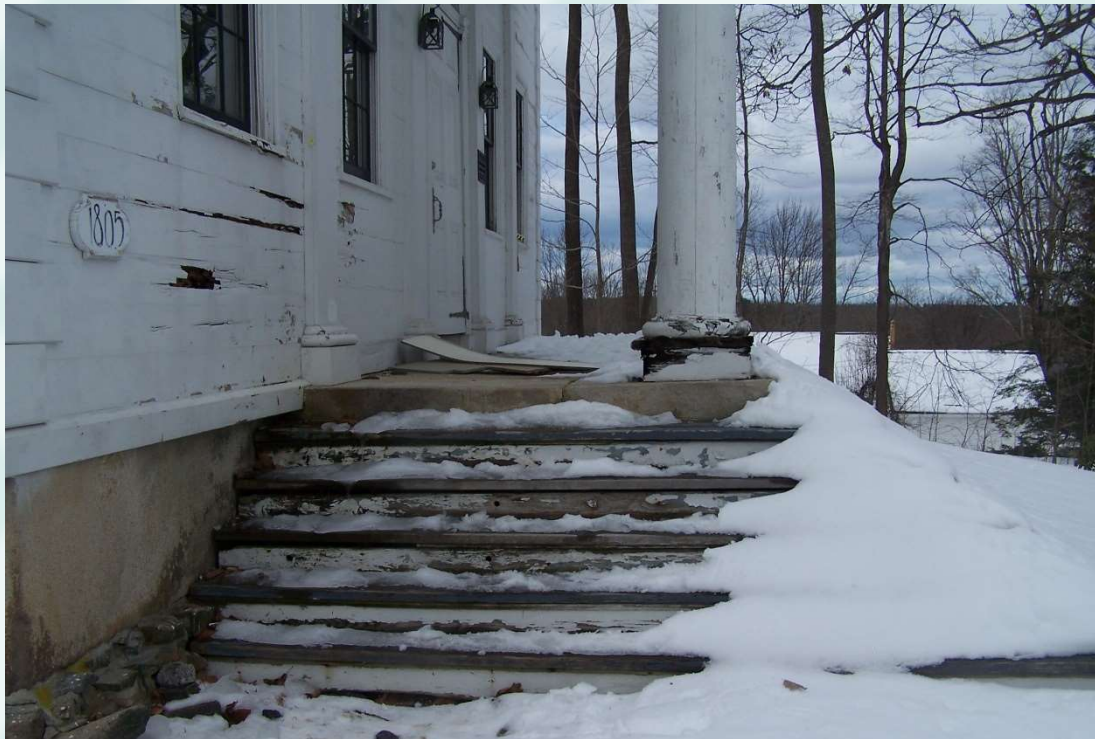
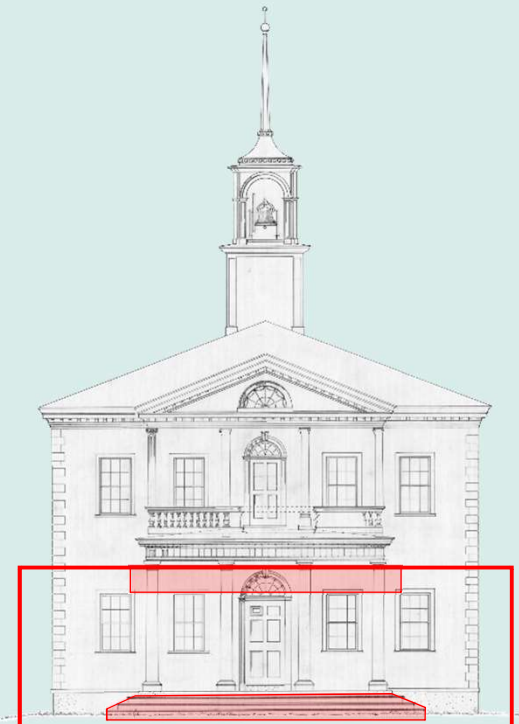
Project 1b Cost: \$92,195

Porch columns, base, capitols, and details;
remove and reset granite; repair foundation; new
wood steps; and siding repair and painting below
second floor
